Metallosis, complete osteolysis of ilium, acetabulum and proximal femur. Disastrous complication of total hip arthroplasty: A case report

Keywords: Metallosis, Eroded ilium, Acetabulum, Total hip replacement, Complication. (JPMA 64: S-54 (Suppl. 2); 2014)

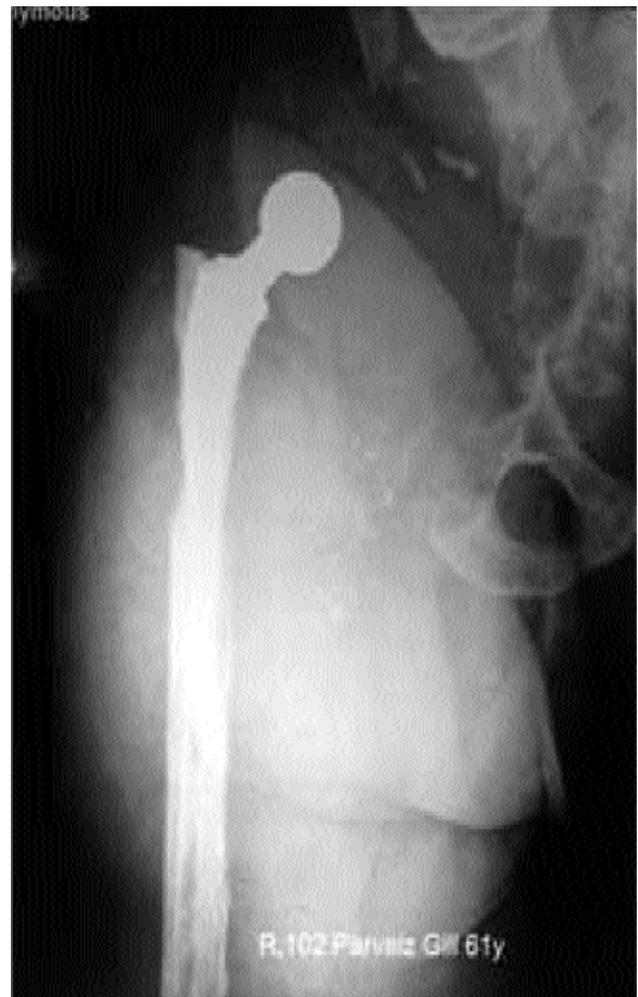
Figure-1: Complete osteolysis of ilium, acetabulum and proximal femur.

Radiologically, osteolysis was seen around the stem, ilium was completely destroyed (Figure-1), medial side of femoral shaft was eroded (Figure-1 & 2), Posterior view showing eroded ilium (Figure-3) and cup was placed at the lower abdomen (Figure-4). Haematological investigations are normal.

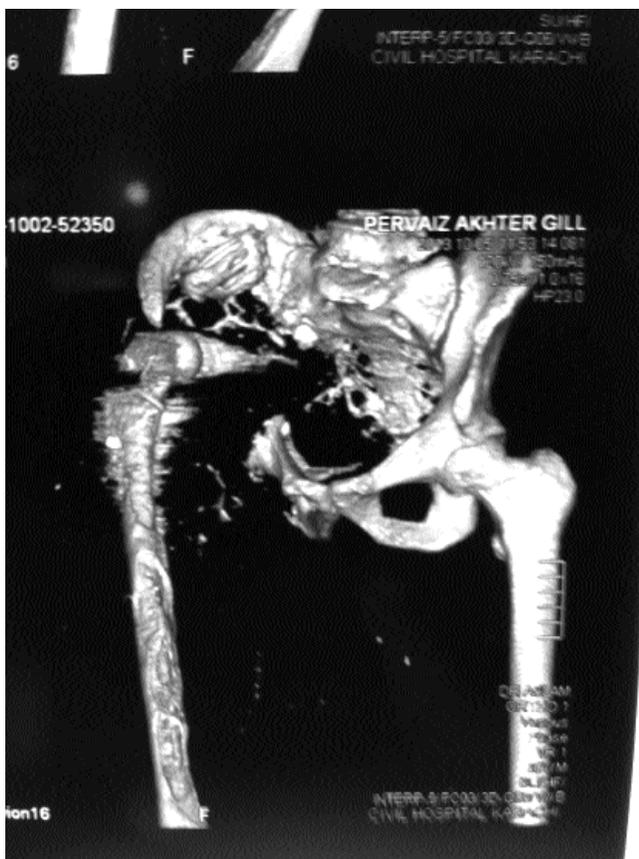
Figure-2: 3D computed tomography (CT) scan showing complete osteolysis of ilium and proximal femur.

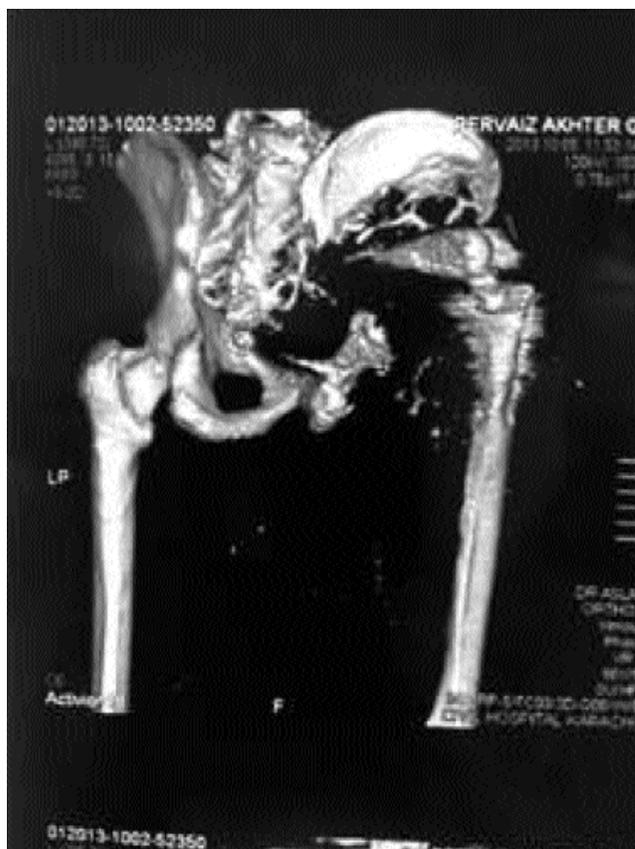
Figure-3: Posterior view.

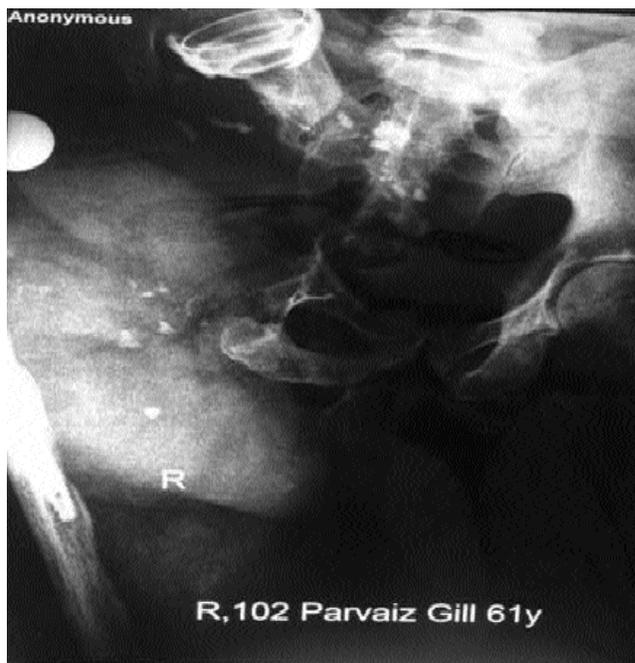
Figure-4: Acetabulum cup migrate proximally in abdomen.
